# Manhole Inspection Summary

Manhole # S17YY1005MH

Insp Date: **11/6/06 1:04 PM**

**Location** Address: **2018 GREENBERRY RD**

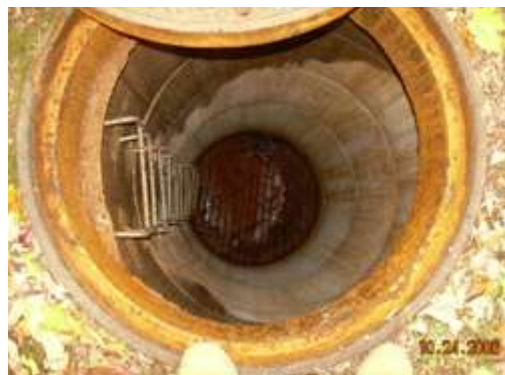
Top View

Channel debris.

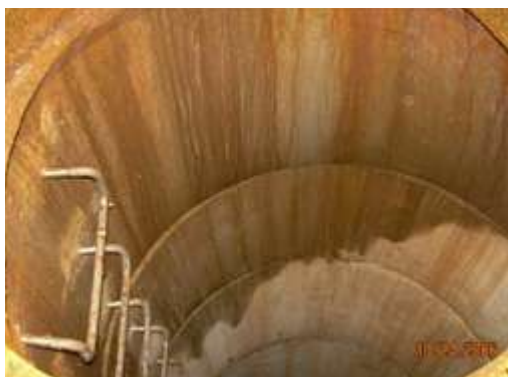
Defect

Adjustment infiltration

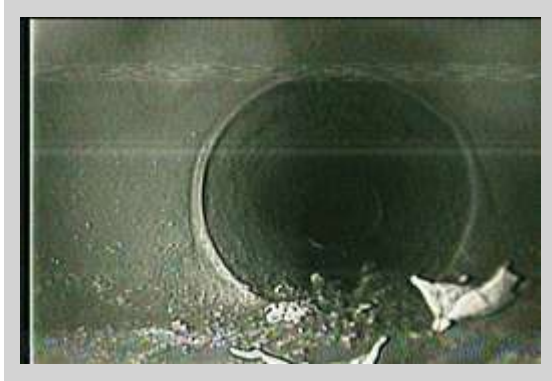
8 in. Circular Gravity Sewer  
Pipe Out @ 12 O'Clock

Deposits: ☐ None ☒ **Mud** ☐ Sludge ☒ **Debris** ☐ Grease

Silt Depth: **0.5** (in.)

Deposits Extent: **Light**
